REPORT DOCUMENTATION PAGE		READ INSTRUCTIONS BEFORE COMPLETING FORM
1. REPORT NUMBER	2. GOVT ACCESSION NO.	3. RECIPIENT'S CATALOG NUMBER
4. PHASE (and Subphase) of Inspection Report Lake Flower Dam Lake Champlain River Basin, Franklin County, NY Inventory No. 707		5. TYPE OF REPORT & PERIOD COVERED Phase I Inspection Report National Dam Safety Program

7. AUTHOR(s) John B. Stetson		6. PERFORMING ORG. REPORT NUMBER
9. PERFORMING ORGANIZATION NAME AND ADDRESS Stetson-Dale Engineering Company Bankers Trust Building Utica, NY 13501		8. CONTRACT OR GRANT NUMBER(s) DACW-51-79-C-0001

PHASE I INSPECTION REPORT
NATIONAL DAM SAFETY PROGRAM
NAME OF DAM - LAKE FLOWER DAM ID# - NY 707

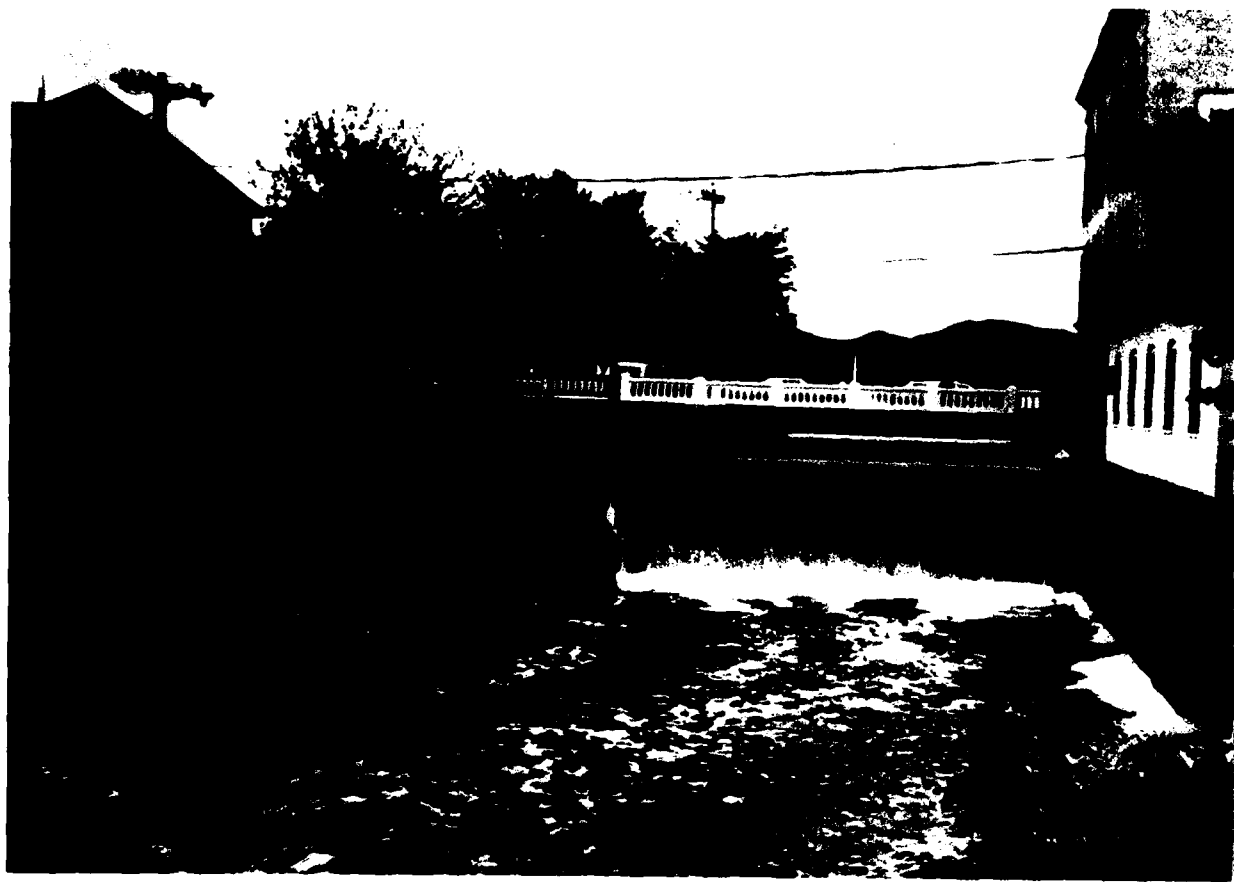
1. Overview of Lake Flower Dam

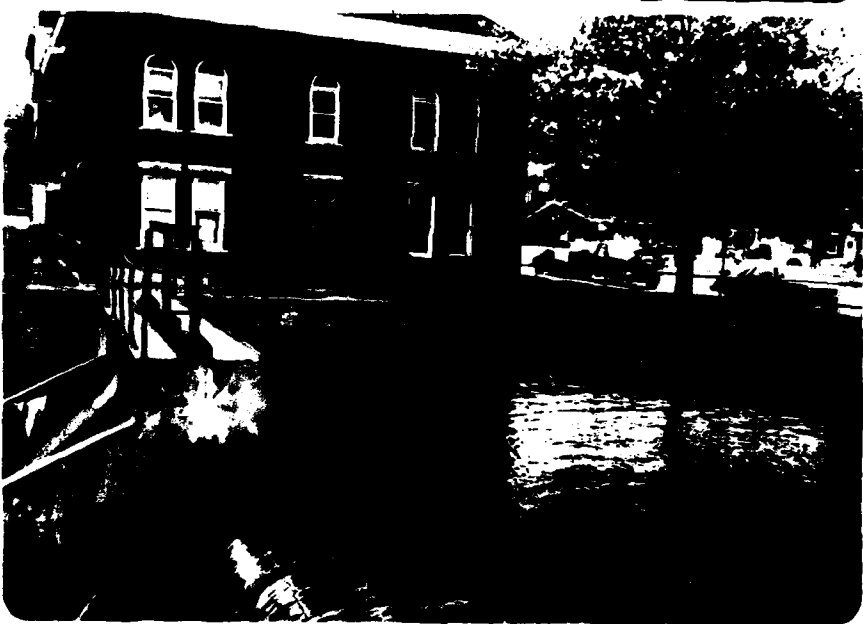
3. View of right abut-
ment showing forebay
control to hydro-
mechanical equipment
in basement of munici-
pal building (red
brick building). Beam
on walkway is used to
support hoist for re-
moving stop planks.

The wall of the Municipal Building which forms the right abutment of the dam was viewed from the basement of this structure. Considerable seepage is taking place through the masonry wall of this structure. The Water Superintendent indicates that this condition has worsened in recent years and that the wall is covered by a layer of ice during the winter season.

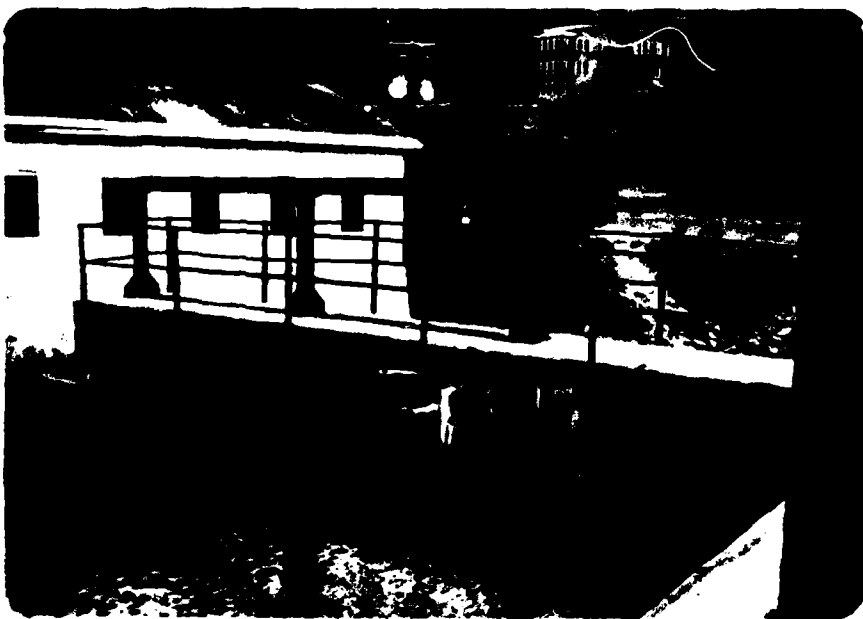
4. Stop plank structure
from upstream.

The stop planks in the outlet structures have been replaced so that the conditions which caused an emergency during 1977 and 1978 have been remedied. However, the Water Superintendent indicates that it is sometimes quite difficult to remove and replace stop planks in the structure.

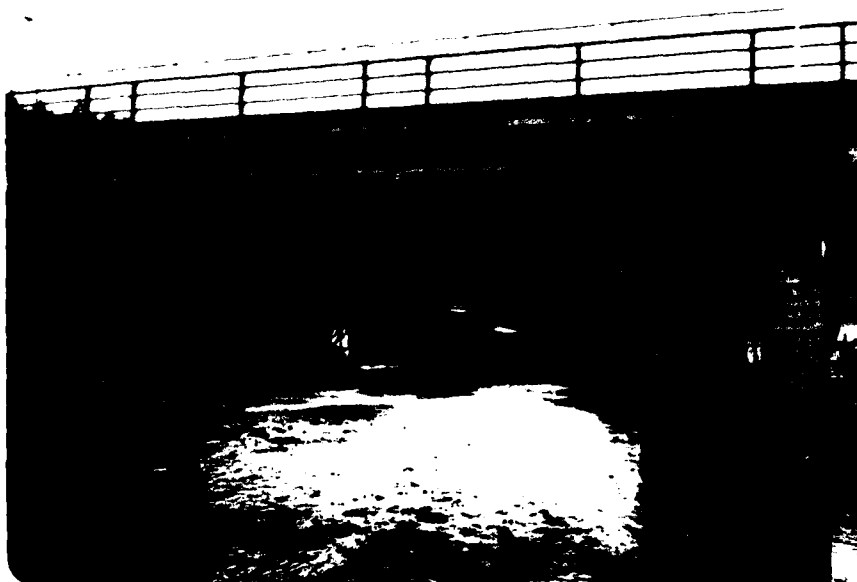
6. Receiving stream showing downstream hazard.

between the elevations for the flood levels with and without the dam failure. The maximum difference determined by this analysis is approximately ten feet, indicating that the downstream hazard would be significantly increased by a dam failure under this condition.

7. A flood warning and emergency evacuation system should be implemented to alert the public in the event conditions occur which could result in failure of the dam.
